Title: **QUALITY AUDIT**

**Road Safety Audit, Access Audit, Cycle Audit and Walking Audit.**

**Carlisle Residential Development, Kimmage Road West,  
Kimmage, Dublin 12.**

Report reference: **1383R01**

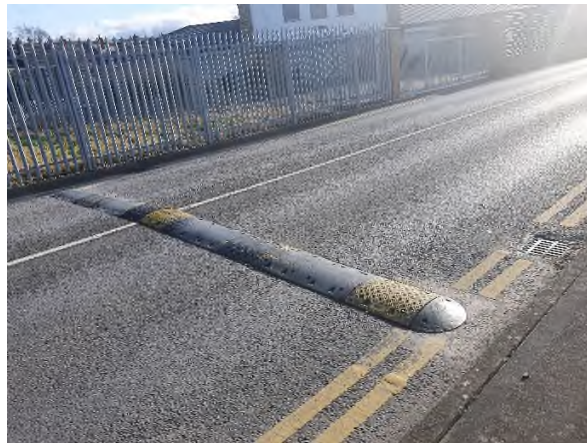
Drawing CST-BMD-00-ZZ-DR-C-1017 PL Rev 2, Main access road.

The main access road to the site is relatively straight and relatively long. This will lead to high vehicle speed and as a result high injury severity if a pedestrian or cyclist is struck by an errant vehicle. It was observed during the site visit that traffic calming measures are currently in place. It is unclear if these or similar are to be retained.

It is recommended that traffic calming measures be provided to ensure slow speeds.

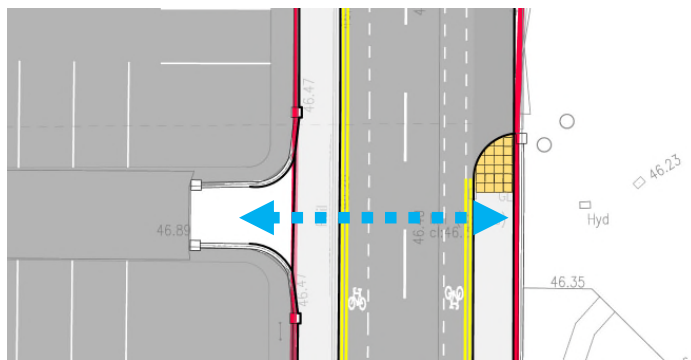
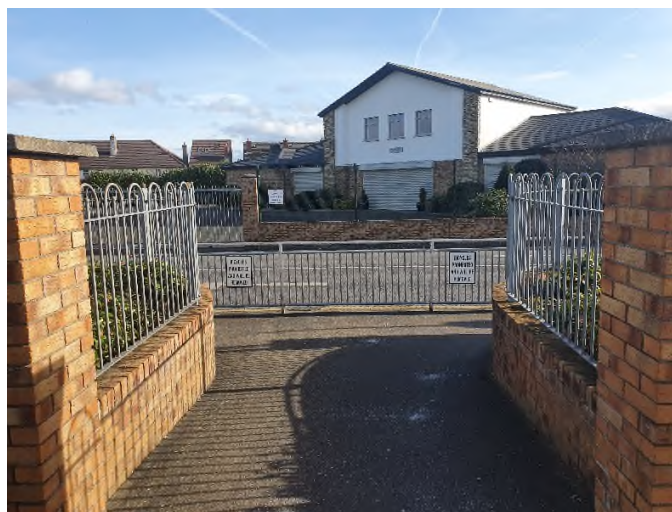
Drawing CST-BMD-00-ZZ-DR-C-1017 PL Rev 2, Main access road, Pedestrian desire line to Ben Dunne Gym.

There will be a pedestrian desire line across the main access road to the pedestrian only access to the Ben Dunne Gym. Without dropped kerbs this could lead to trips and falls. It was noted during the site visit that there is a pedestrian guardrail on the footpath. It is unclear if it is proposed to retain the railing.

It is recommended that dropped kerbs and suitable tactile paving be provided to cater for the pedestrian desire line.

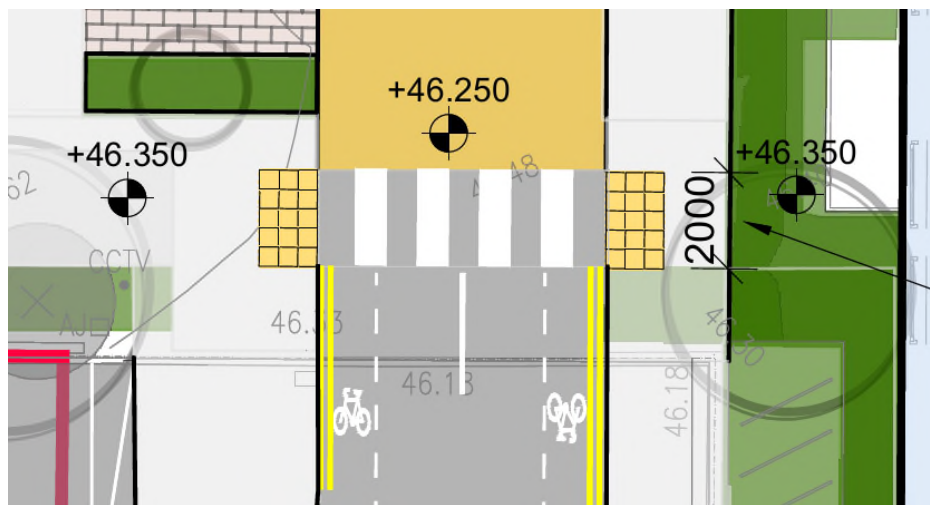
Drawing CST-BMD-00-ZZ-DR-C-1017 PL Rev 2, Main access road, Start of shared use road.

There is a proposed pedestrian crossing at the start of the shared use road. It has proposed zebra type black and white stripes which may lead to confusion over priority. Pedestrians may think that they have priority given the presence of the stripes but drivers may not think so due to the lack of flashing beacons. The confusion may lead to collisions between vehicles and pedestrians.

It is recommended that the stripes be removed and that an uncontrolled crossing be provided.
